MANAGEMENT OF CHALLENGES DURING THE CONSTRUCTION OF OFFSHORE FACILITIES

OVE T. GUDMESTAD
University of Stavanger, Norway.

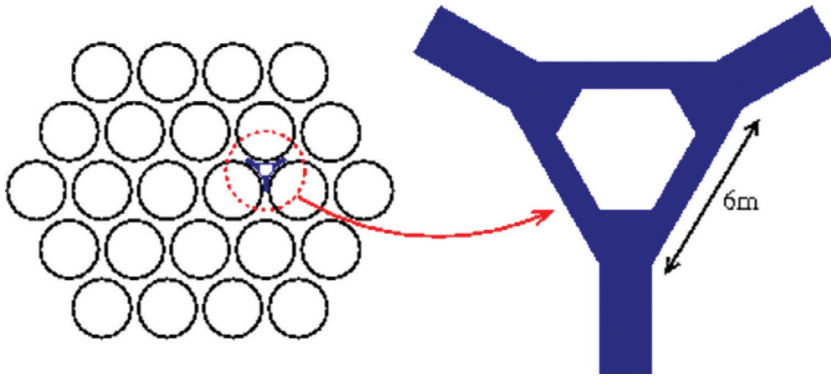
The failure of the analysis led to 47% underestimation of shear stresses in a critical region and subsequently to insufficient reinforcement and insufficient anchorage of the reinforcement in the critical zone. As soon as the investigation was concluded, the construction of a second Sleipner A was started, this time, with sufficient reinforcement and with careful steel stirrups reinforcement keeping the rebars connected across the cross-section of the concrete wall in all critical sections of the platform.

Figure 2: Failure in design of tri-cells of the Sleipner A platform.

Following the loss of the platform, a new platform with the same geometry, however, with proper reinforcement was constructed. One of the partners in the licence involved themselves strongly by sending one of their most experienced engineers, specializing in concrete design, to join the project group.

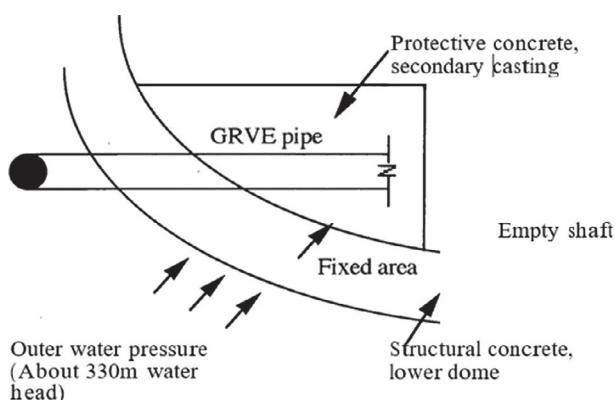
Late in the construction phase it became evident that there could be a risk of pipe leakage due to the possibility of clipping the 2" and 8" glass-fiber reinforced composite pipes in the riser and utility columns (the outer edge columns) of the concrete platform during submergence testing and deck transfer. Clipping would result from movement between the structural

Figure 3: Section of the lower dome of the concrete platform, showing GRVE pipes and protective concrete [20].

concrete in the lower domes and the non-structural protective concrete above. Eventually, the clipping could result in loss of the platform due to rapid flooding of these shafts, causing the platform to sink. At this time, the loss of Sleipner A during the submergence phases was fresh in the mind of all involved in the project. The probability of clipping with resulting leakage of one or several of the 8 inches GRVE pipes in the concrete platform was estimated to be 2.6×10^{-1} as calculated using the PROBAN software [20]. The failure probability of each individual GRVE pipe was defined as the probability that the local clipping displacement each pipe was exposed to was larger than the clipping capacity for this pipe.

Due to strong warnings from persons 561 and 481 supported by 261 and 264 as well as 391, the project organization concluded that action was necessary at a rather high extra cost to the project to reduce the risk of sinking to a very low level [20]: a large number of the vulnerable ballast pipes were plugged, and the platform was submerged only to a minimum level during platform commissioning phase at the Stord Yard prior to tow to offshore site.
